Alaris™ Pump module Model 8100

Frequently Asked Questions (FAQ's)

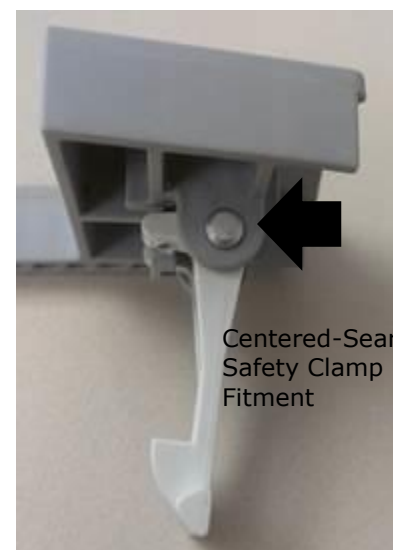
Centered-Sear Safety Clamp Fitment Design
Manufactured 2002-2004

User can reproduce a free-flow condition if the clinician does not close the roller clamp on the IV administration set prior to opening the pump door and the pump door is opened by using a "flick" of the door latch that causes the door to "pop" open instead of opening the door by slowly raising the latch. This flicking motion may cause the centered sear design to not effectively engage with the safety clamp fitment.

Both of these actions leave the roller clamp and safety clamp fitment in the open position which can cause unintended flow possibly resulting in an over infusion to the patient.

These two scenarios can be found on the centered sear door latch manufactured between June 2002 to June 2004.

Safety clamp fitment inactivation due to non-optimal engagement of sear to the slide clamp could result in an over infusion. Over infusion can result in serious life-threatening patient injury.

BD will contact all affected Alaris System Pump module customers by mail to notify them of this Medical Device Recall Notification. Customers will receive a customer letter, Frequently Asked Questions, and customer response card. The customer should sequester the device or kit so that Biomedical Engineering can verify the issue. If the door latch needs to be replaced, then Biomedical Engineering should contact BD to coordinate an onsite remediation or send the devices to the BD Service Depot.

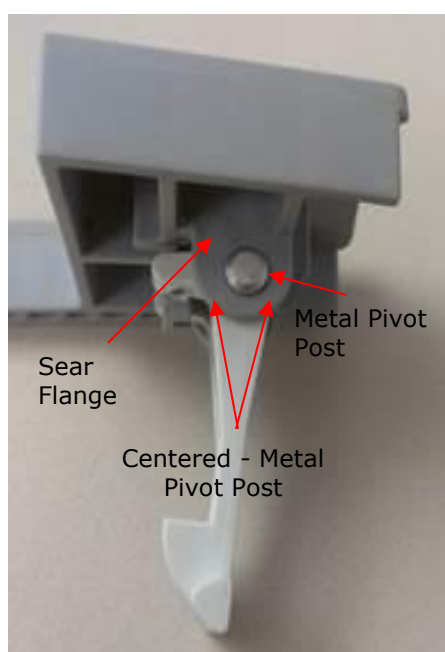
Image of Centered-Sear Safety Clamp Fitment
(Affected Product)

The centered-sear safety clamp fitment is identified by the centered position of the metal pivot post located on the inside of the door latch assembly sear flange.

If the pump or kit has been confirmed as having a centered-sear safety clamp fitment, contact BD Support Center at 888-562-6018 to schedule the remediation of your device(s).

The customer should sequester the device so that Biomedical Engineering can verify the issue. If the door latch needs to be replaced, then Biomedical Engineering should contact BD to coordinate an onsite remediation or send the devices to the BD Service Depot.

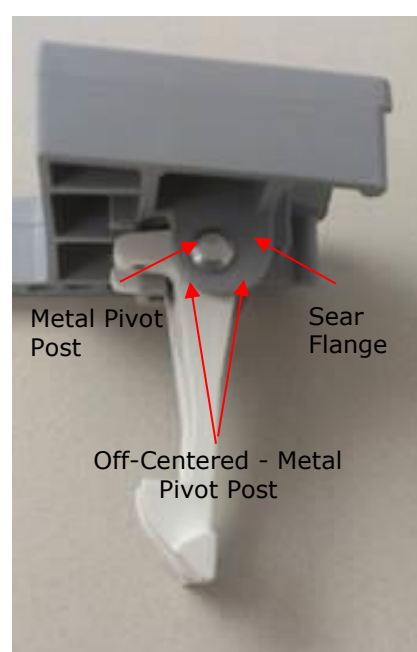
Image of Off-Centered-Sear Safety Clamp Fitment
(Current Production)

If an affected pump has already been replaced with an off-centered safety clamp fitment, then the pump does not need to be remediated.
